## **DAM SAFETY SECTION CRITICAL INFRASTRUCTURE DIVISION**

### **Dam Safety Inspection Report**

DAM: Lake Dunlap Dam

CURRENT INSPECTION DATE: 6/13/2018

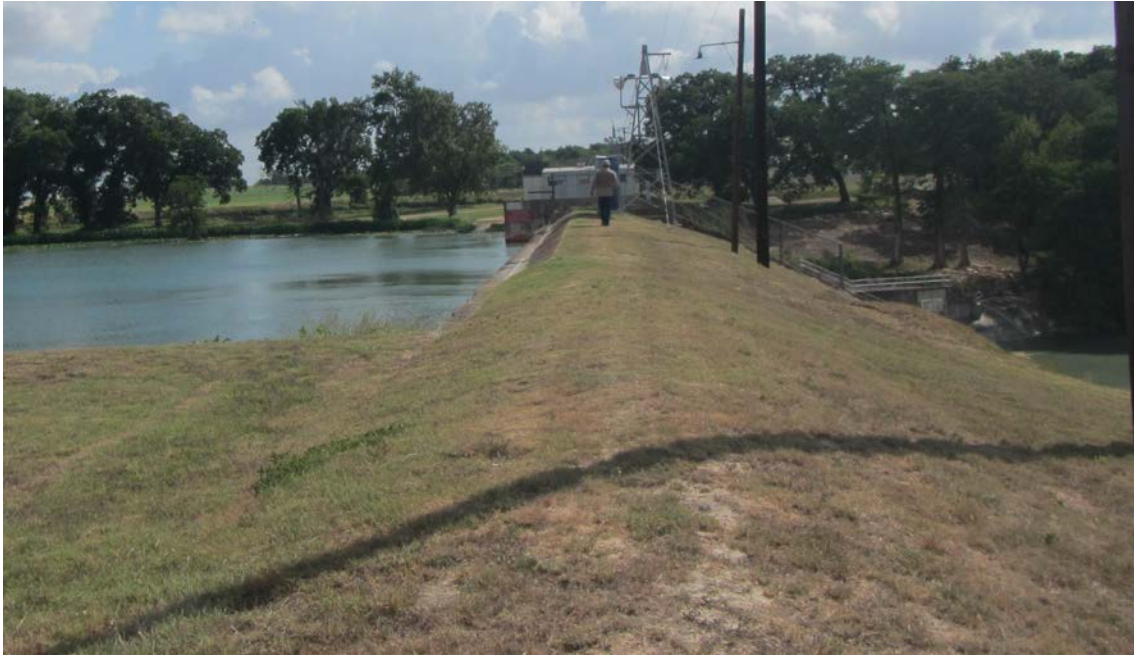
- The crest consists mostly of a short good grass surface with some areas where the grass was longer. The section south of the river has a slight crown while the section north of the river is relatively flat. The crest was found in good overall condition (See Photos 1-4).

**Photo #1** – Crest of dam from south side of river looking northeast (Approx. 8-ft wide). Note the slight crown and good grass cover.

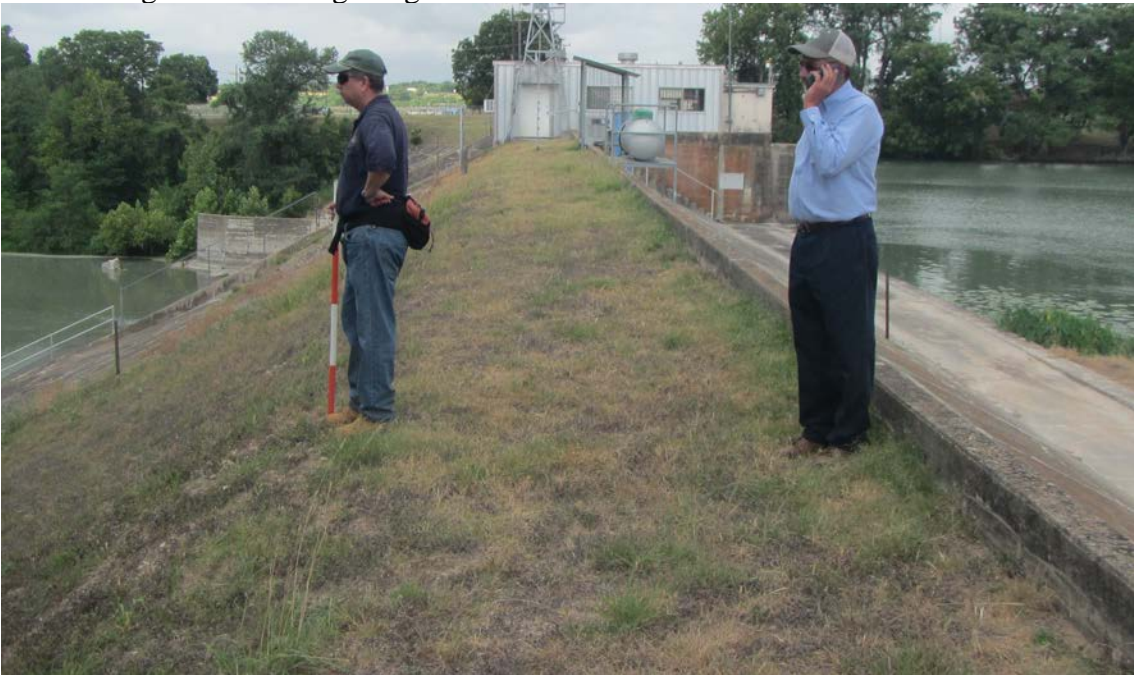
**Photo #2** – Crest of dam from north side of the river looking southwest (Approx. 8-ft wide).

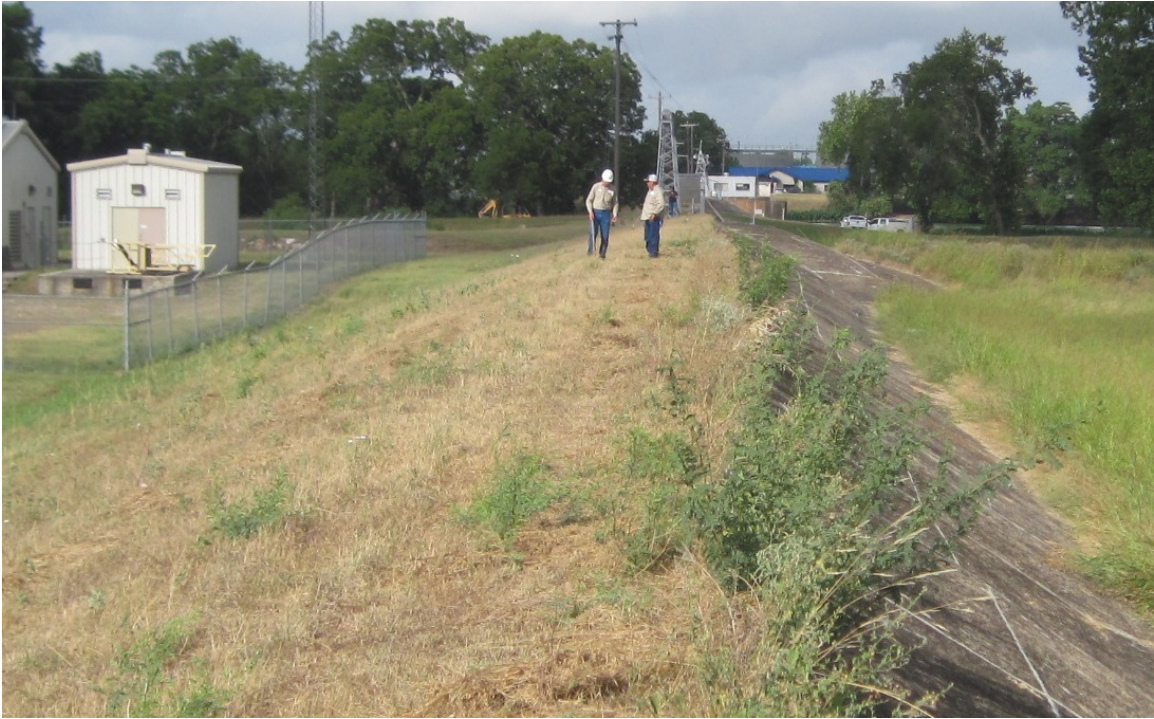
- The crest was mostly level with no significant dips or low spots noted. However, 2011 LiDAR data noted in the previous inspection provides evidence that some low areas exist relative to the top of dam (the effective top of dam may be over 1.5-ft lower than TCEQ records). However, it is unknown if the LiDAR data accounts for the parapet wall in this location.

**Photo #3** – Crest of dam north of the diversion canal looking southwest. Note the crest appears to be slightly uneven along this section.

3. LiDAR data (from 2011) identified low areas along the crest as well as differences (higher elevation of the emergency spillway) from what is currently noted in the Texas Inventory of dams. It is recommended that a level survey be conducted to identify on the ground elevations as well as to provide accurate information in conjunction with any future H&H analysis. Lastly, until a comprehensive plan is in place to address hydraulic adequacy, it is recommended that the results of the survey be applied to level the top of dam and reduce the high areas of the emergency spillway.

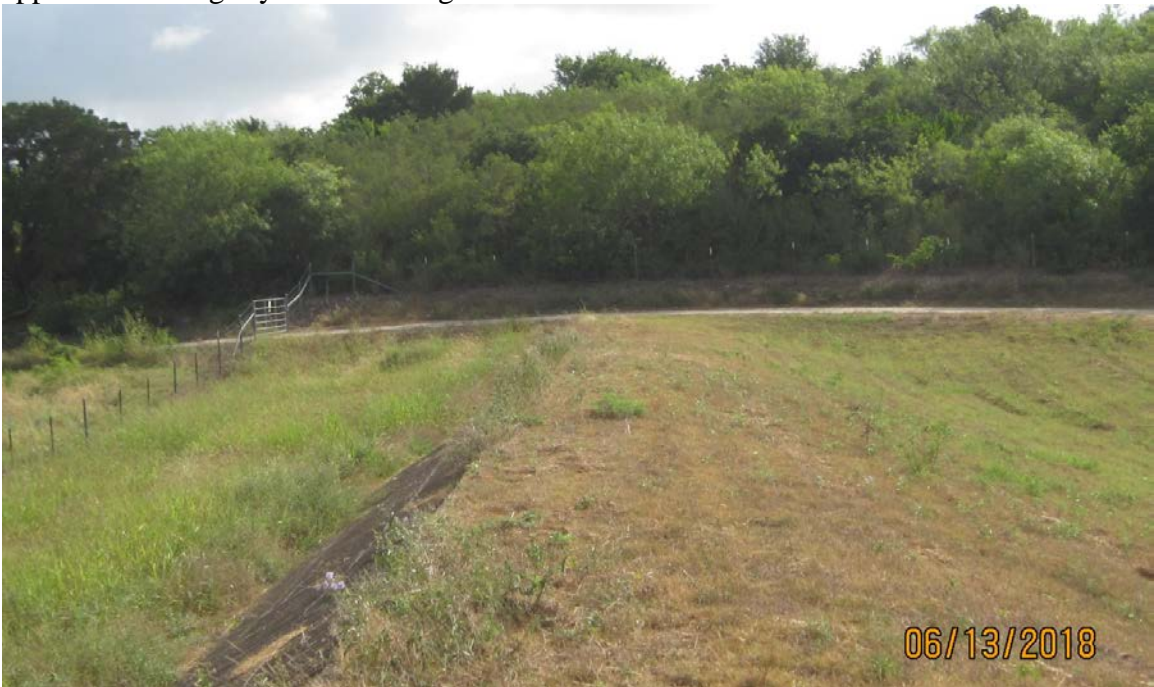
**Photo #4** – Crest of dam north of the diversion canal looking northeast.

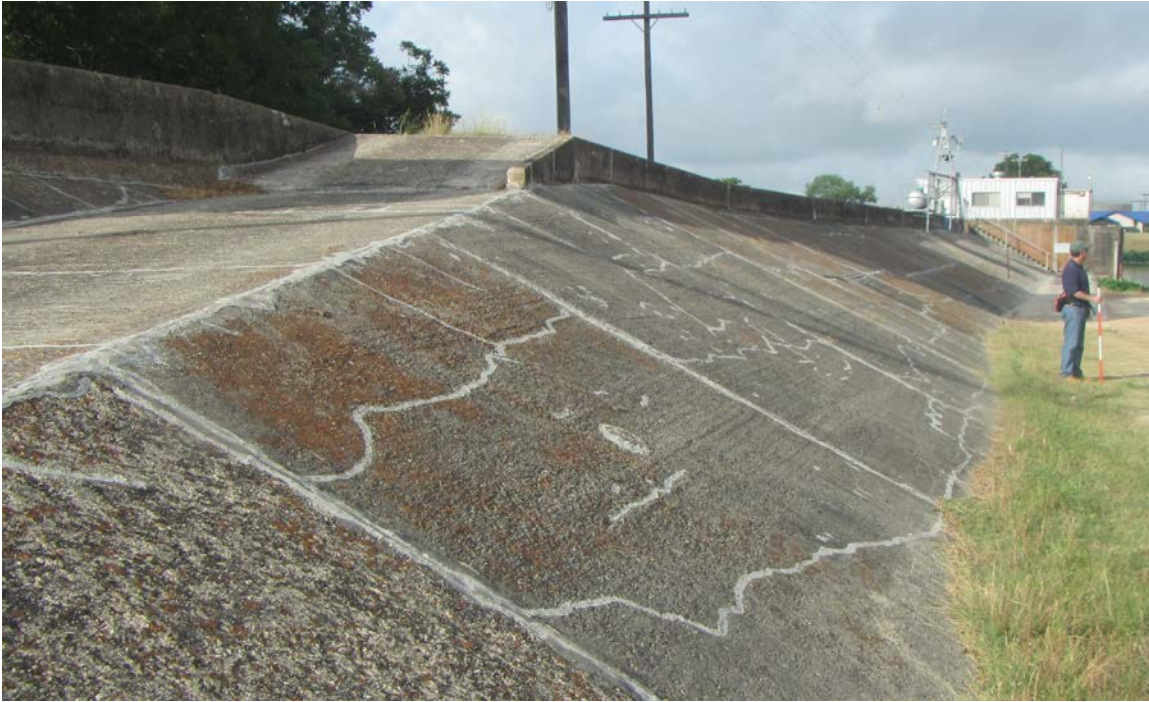
**Photo #5** – View of dam's upstream slope north of the river looking southwest. Note all of the concrete slope protection is patched and sealed at all of the joints and cracks.

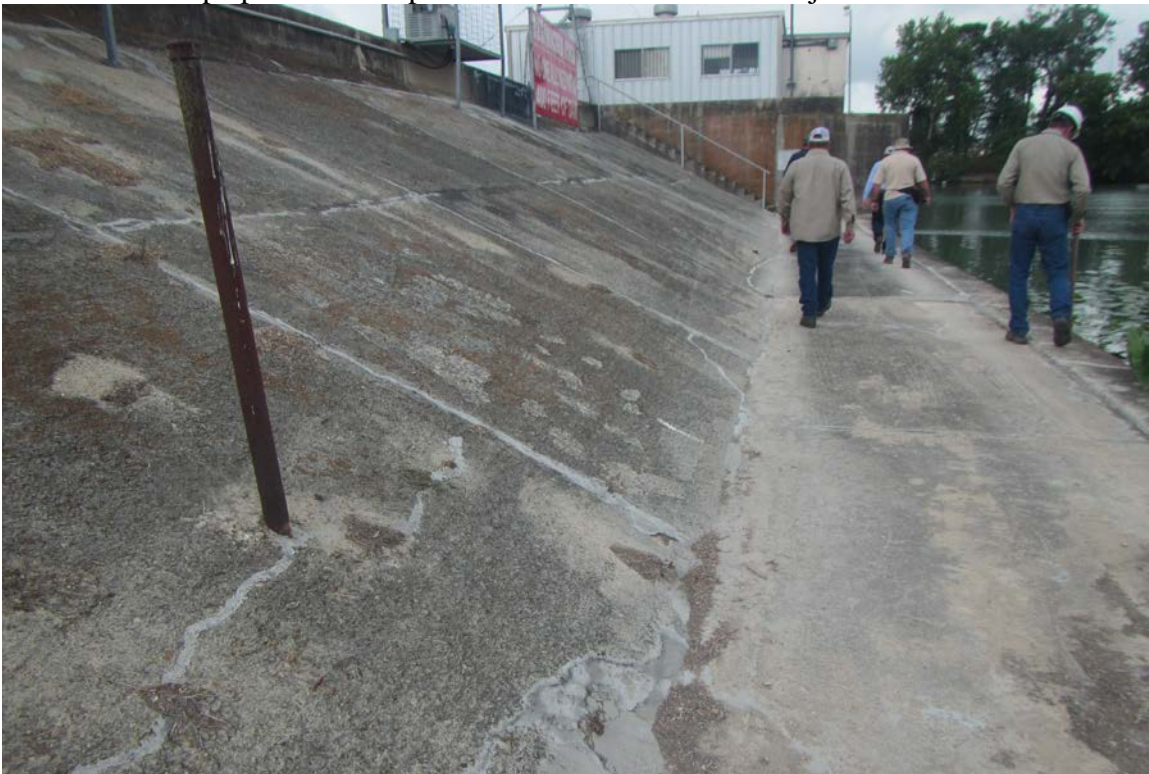
**Photo #6** – View of dam's upstream slope north of the river looking southwest. No open joints or cracks were left unpatched.

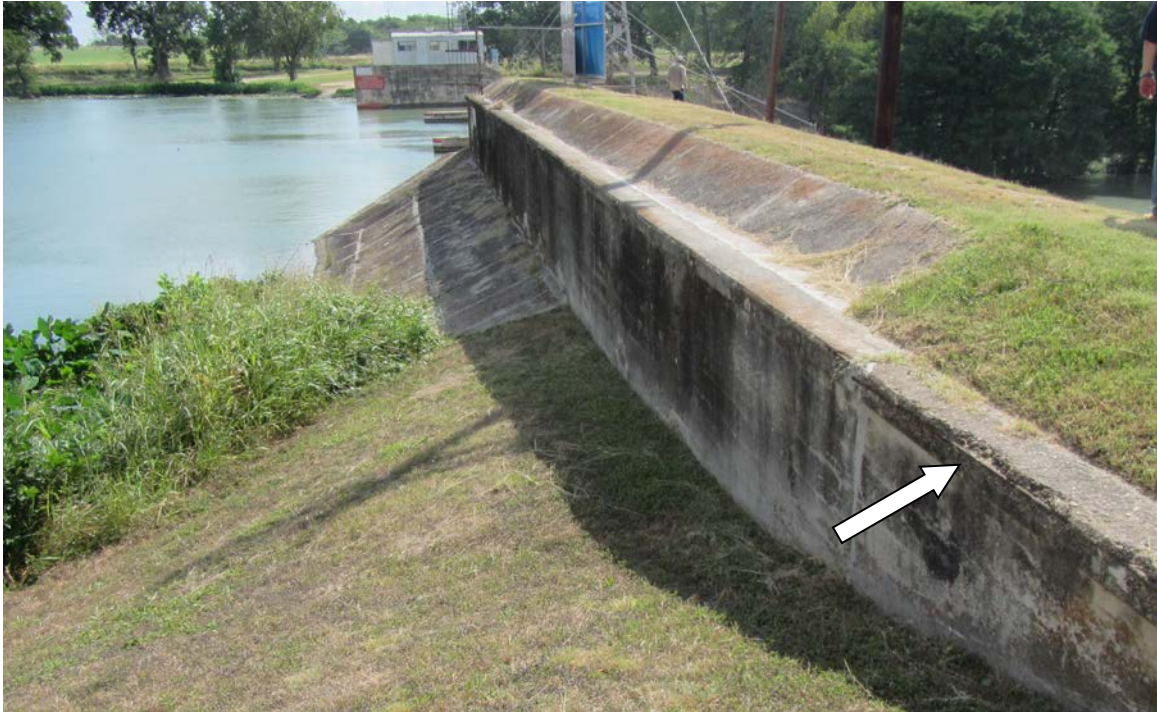
**Photo #7** – View of dam's upstream slope south of the river looking northeast. The walls and slope protection are in good condition. However, some exposed rebar was noted in the concrete wall (arrow).

- c) Continue the maintenance program of sealing all open joints and cracks, and patching spalls and exposed rebar in concrete throughout all components of the structure.

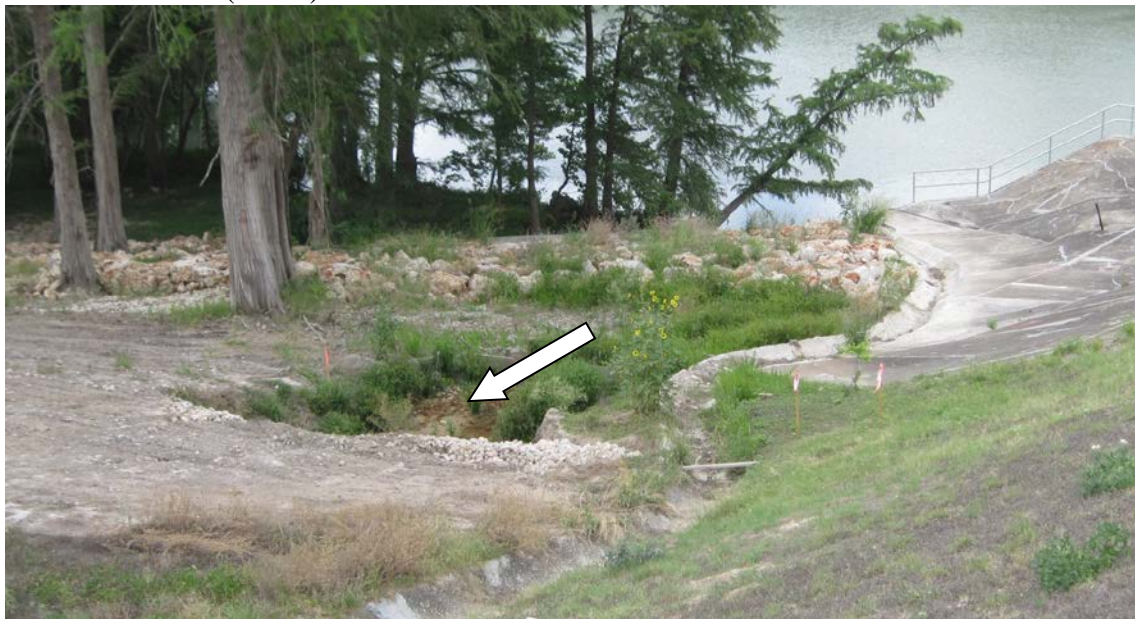
- The groin area at the toe of the downstream slope nearest the north side of the spillway had a consistent seep. GBRA staff graded the topsoil layer and placed rock rubble and a temporary weir that was previously capable of measuring the flow. However, the seepage was noted to be passing beneath the weir and was not being measured.

- GBRA staff explained that they were in consultation with their engineer to come up with a long-term solution for this seepage layer. Seepage had been noted in this location in previous inspections.

**Photo #8** – View of dam's downstream slope north of the river looking south. Note the slope in this area has been graded to expose a seepage layer. GBRA staff were in the process of determining the full extents of the seepage and working with their engineer to develop a long-term solution.

7. The following are recommendations for addressing the maintenance items noted during the inspection:
    - a) In consultation with a Texas Licensed Professional Engineer (TLPE) with dam safety experience identify a long-range solution for the layer of seepage along the left downstream side of the groin area near the service spillway. Any proposed plans need to be submitted to TCEQ Dam Safety for review and approval prior to beginning construction.

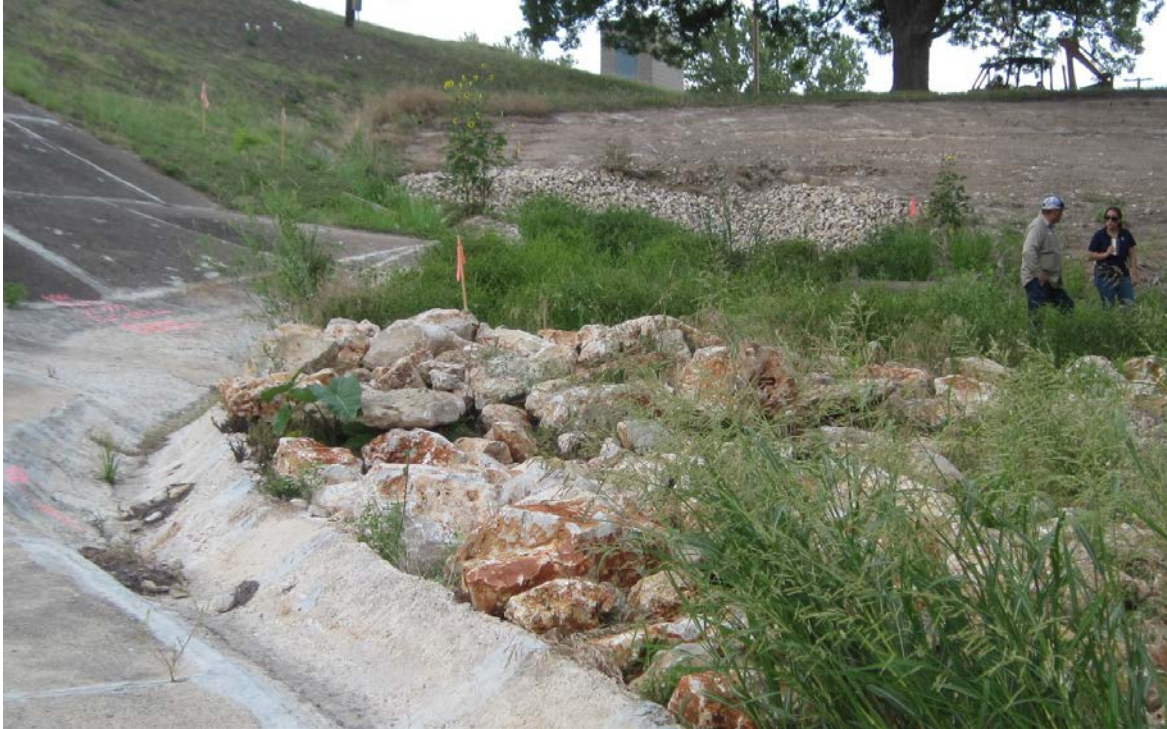
**Photo #9** – View of dam's downstream slope north of the river looking north (at location of seepage layer).

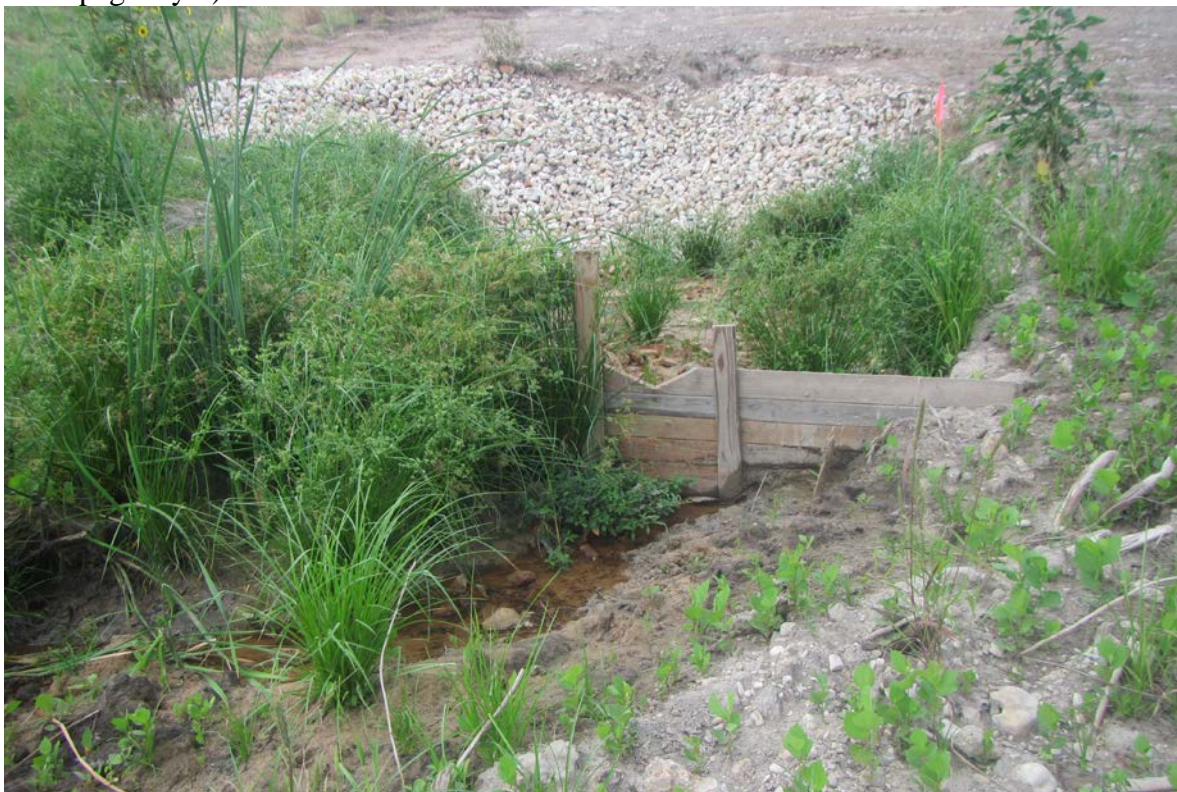
**Photo #10** – Close up view of seepage passing beneath the temporary weir.

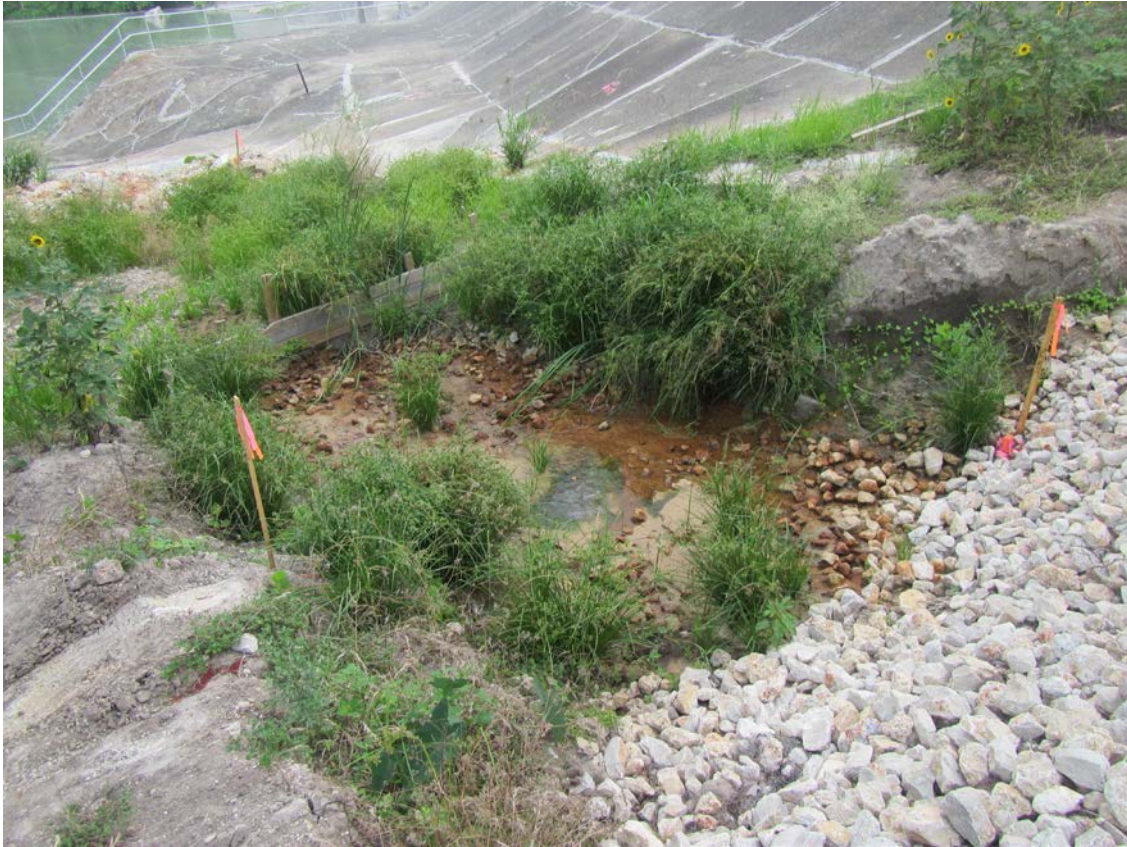
**Photo #11** – Close up view of seepage layer looking southwest.

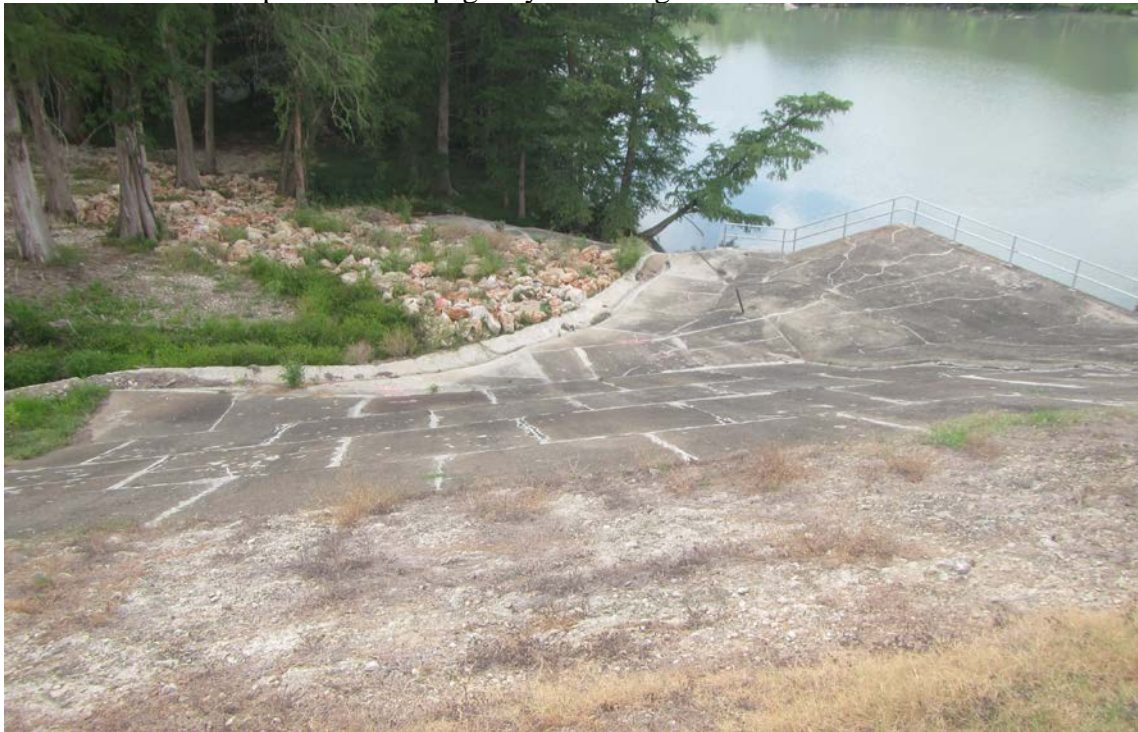
**Photo #12** – View of dam's downstream slope north of the river looking southeast. The concrete apron is worn but has been sealed and patched.

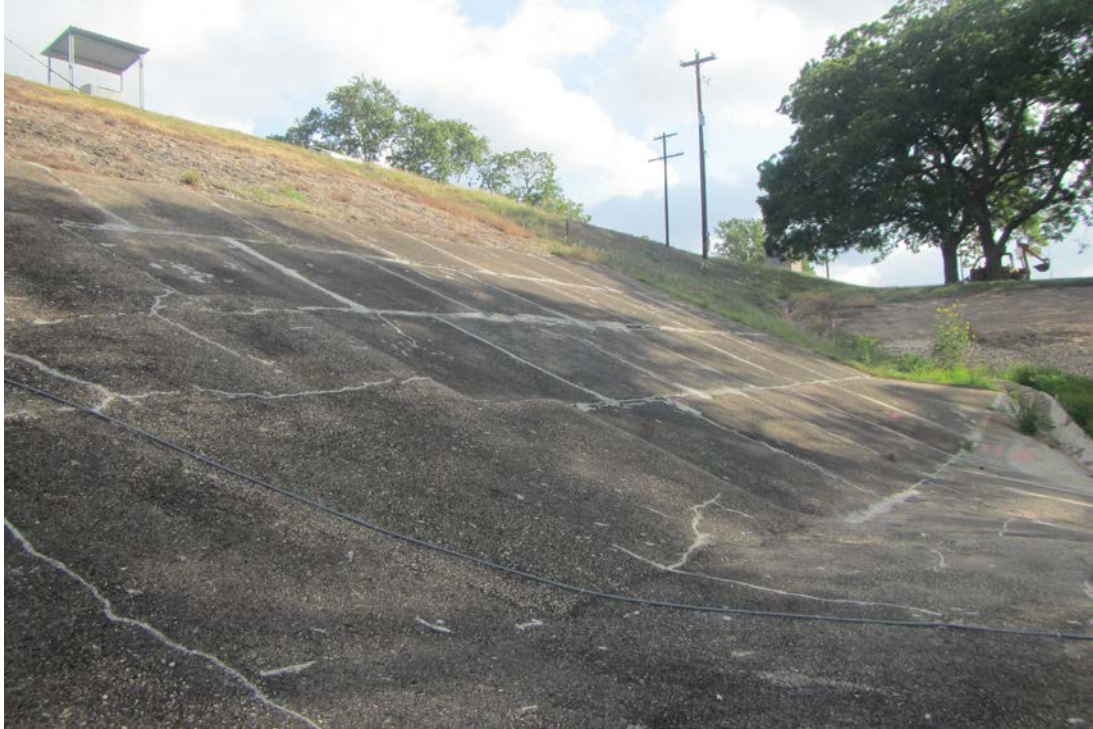
**Photo #13** – View of dam’s downstream slope north of the river looking northeast. The concrete apron is worn but has been sealed and patched and is functional.

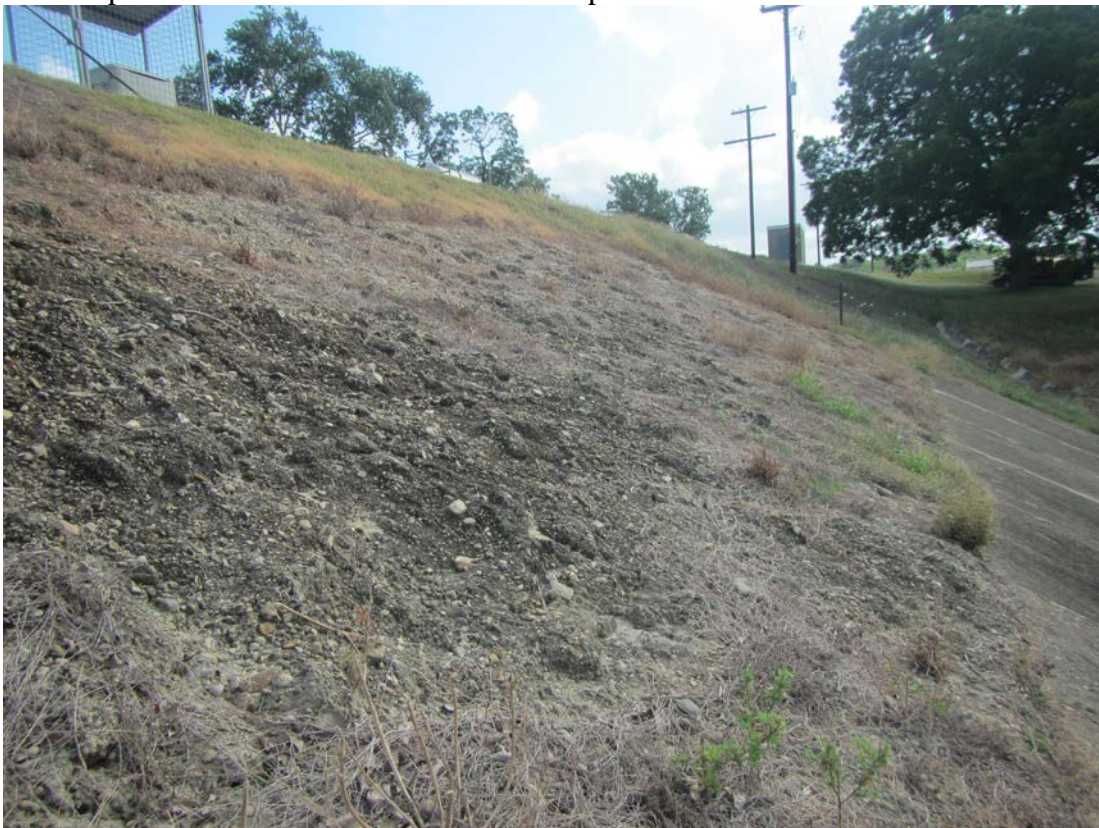
- The concrete apron section along the downstream slope had all open joints and cracks sealed and patched. No gaps or separations in the concrete were noted. A soil-cement section located above the concrete apron appeared to be stable with no breaks or buckling noted. However, there was a little grass growing through the soil-cement section.

**Photo #14** – View of dam’s downstream slope north of the river looking northeast. A layer of soil cement was placed above the concrete apron to help stabilize the slope.

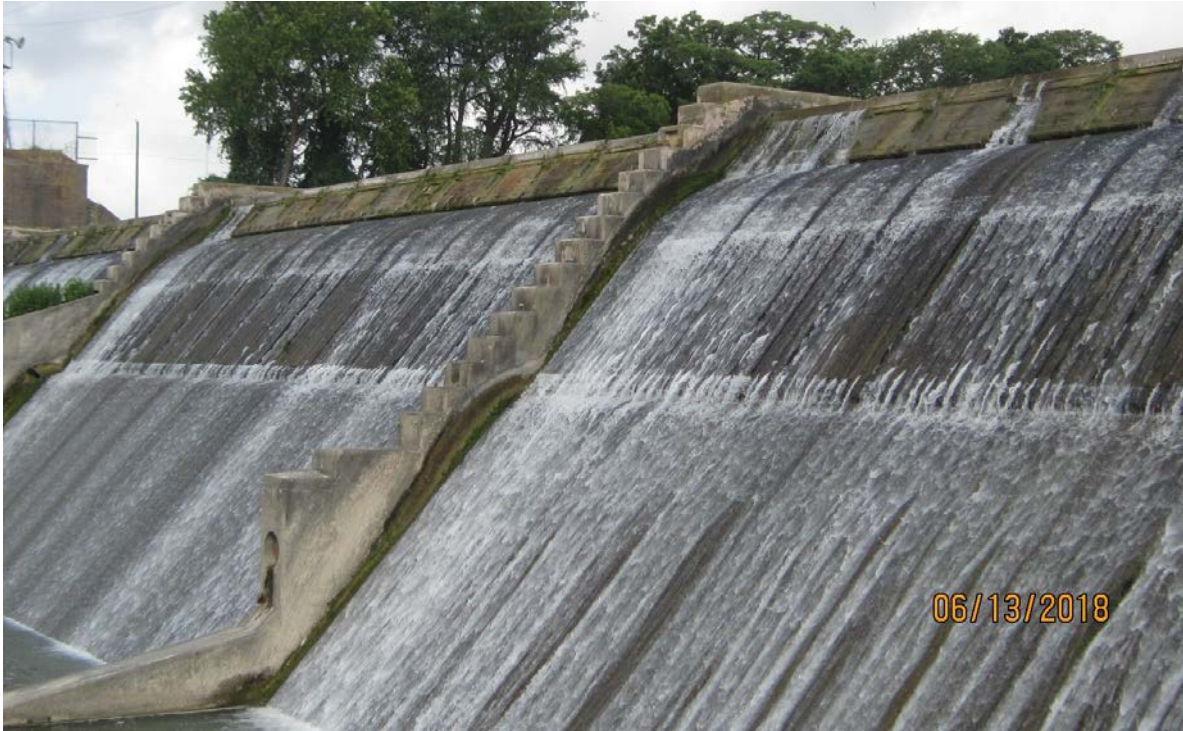
**Photo #15** – View of the service spillway and gates looking west.

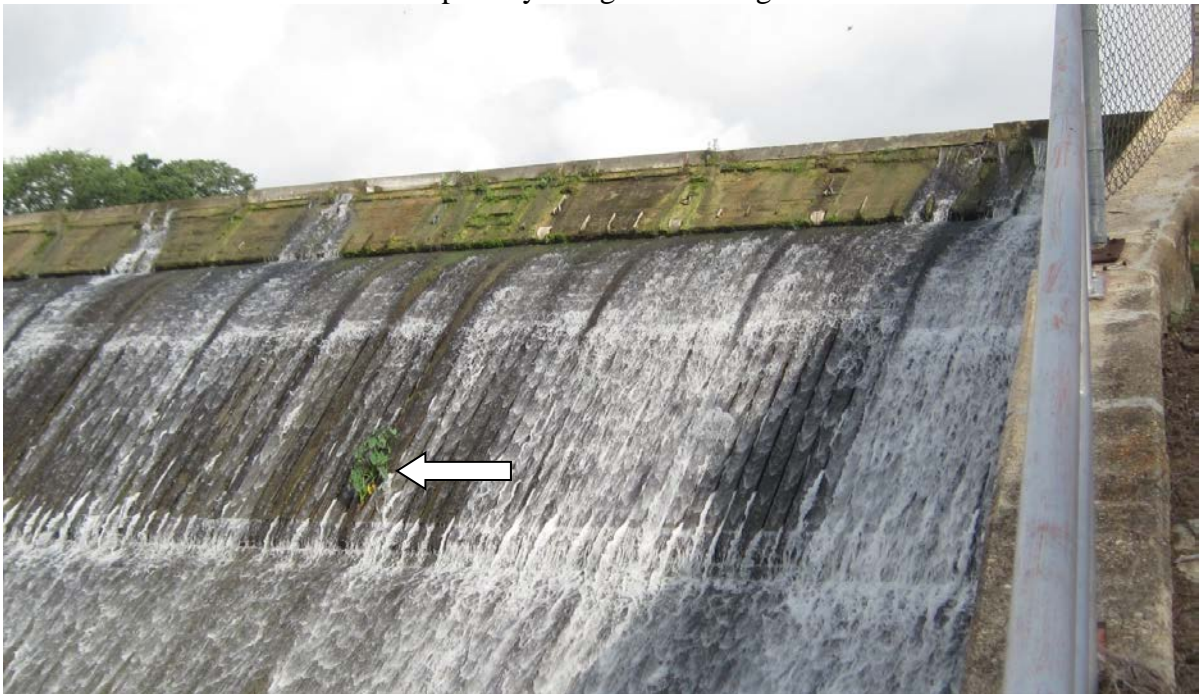
- Unwanted vegetation was noted (small shrub) growing through some of the boards on the gates.
- The previous inspection noted several cracks and open joints in several areas of the concrete structure that had been sealed or

**Photo #16** – View of the service spillway and gates looking west. Note vegetation growing through timber near the bottom of the gate.

- e) Remove unwanted vegetation growing on the timbers of the spillway gates and along walls, weep holes, and structure of the spillway, as well as sediment buildup and vegetation in fish ladder.

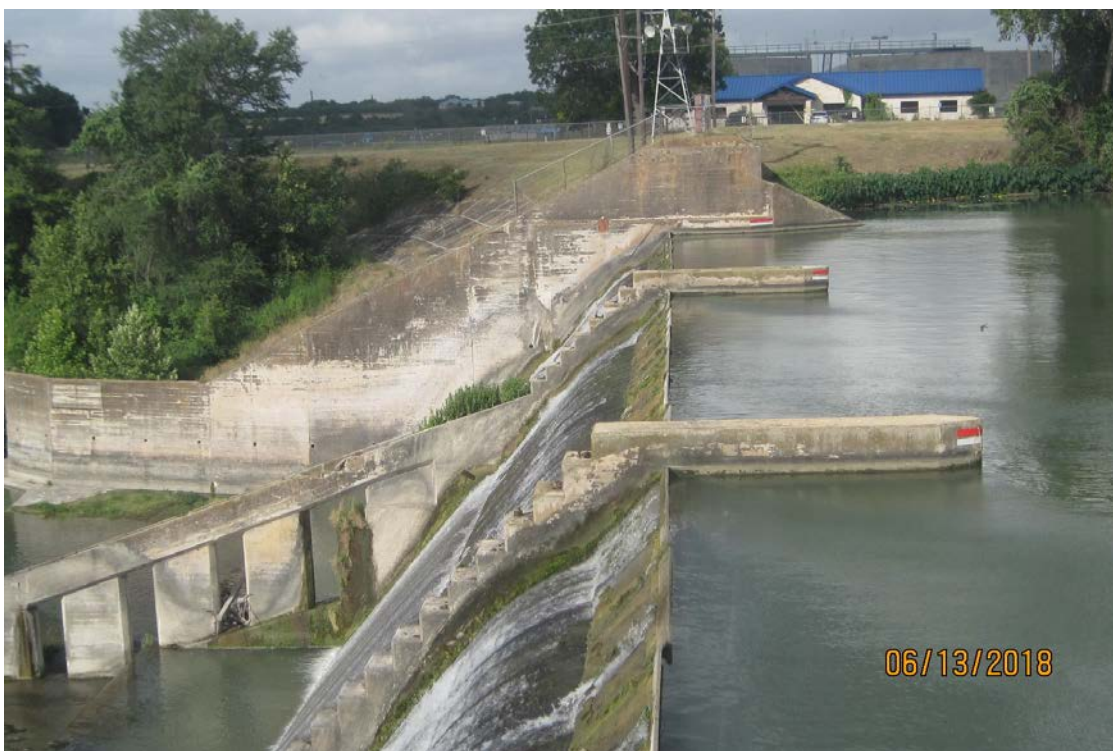
**Photo #17** – View of the service spillway and gates looking southwest.

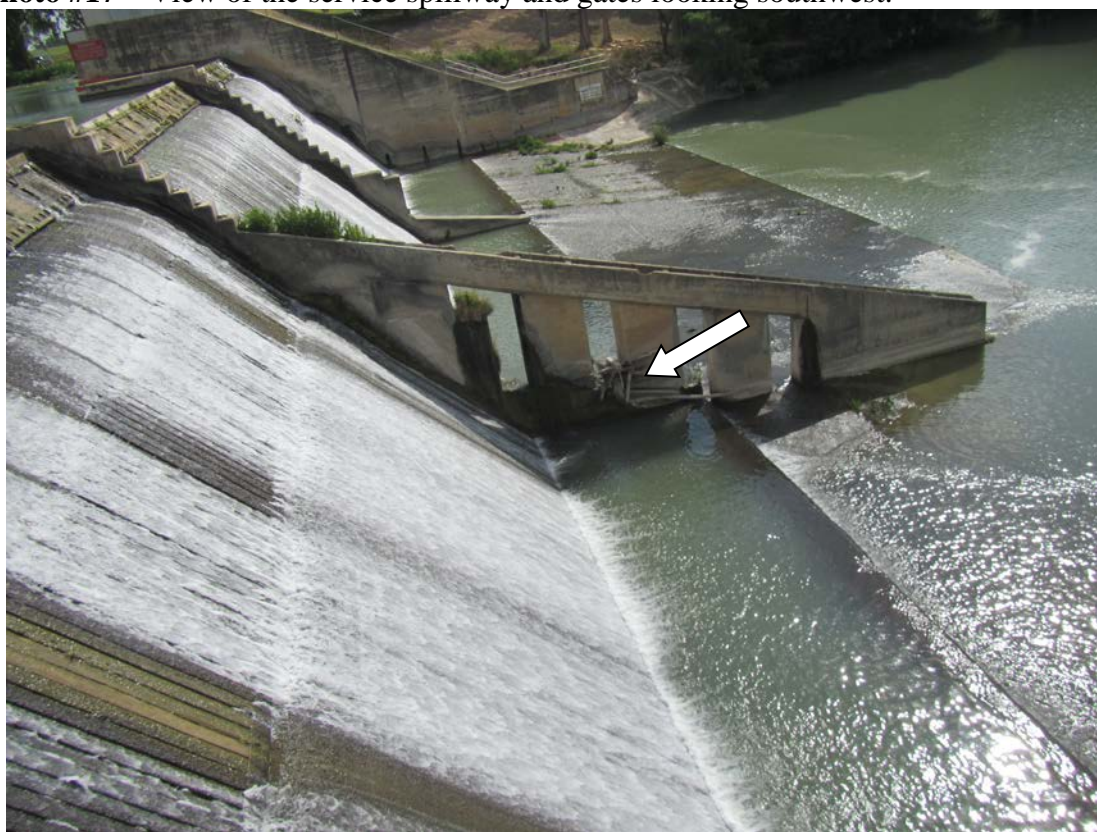
- Cracks, spalls, and separations noted in the downstream wing walls during the previous inspection appeared to be in about the same condition.
- The fish ladder structure exhibited cracks and spalls along with sediment buildup and vegetation.

**Photo #18** – View of the service spillway and gates from south of the river looking northeast. Note debris and sediment (arrow) that has built up around the base of the splash pad and fish ladder structure.

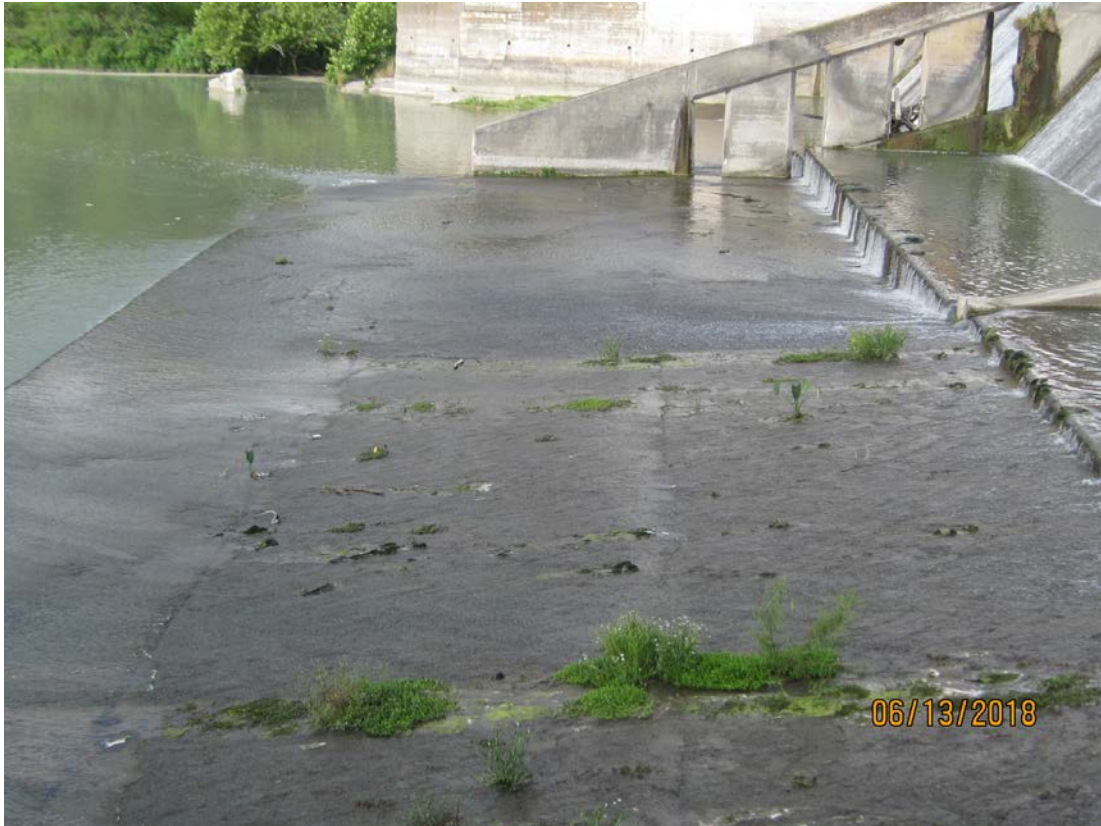
**Photo #19** – View of the splash pad at the base of the spillway looking southwest. The concrete pad has some sediment buildup and vegetation.

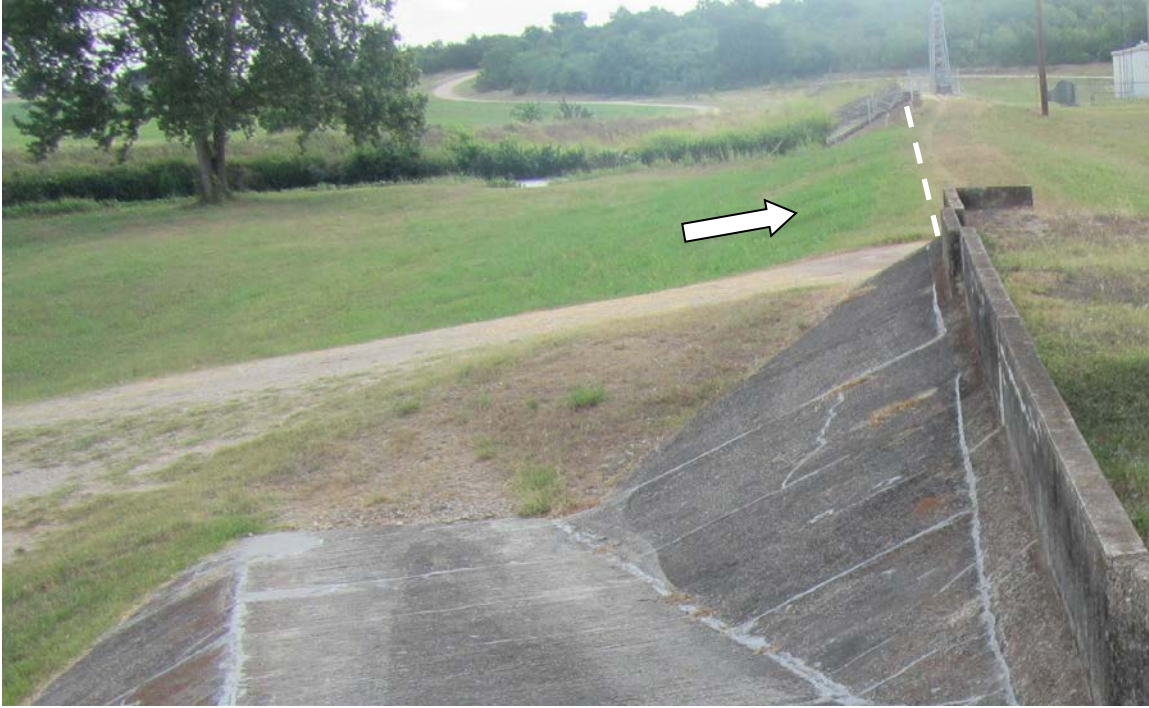
**Photo #21** – View of the emergency spillway from just north of the river looking northeast. Note the concrete structures indicate the control point of the spillway from the embankment sections of the dam. Flow would be from left to right (arrow).

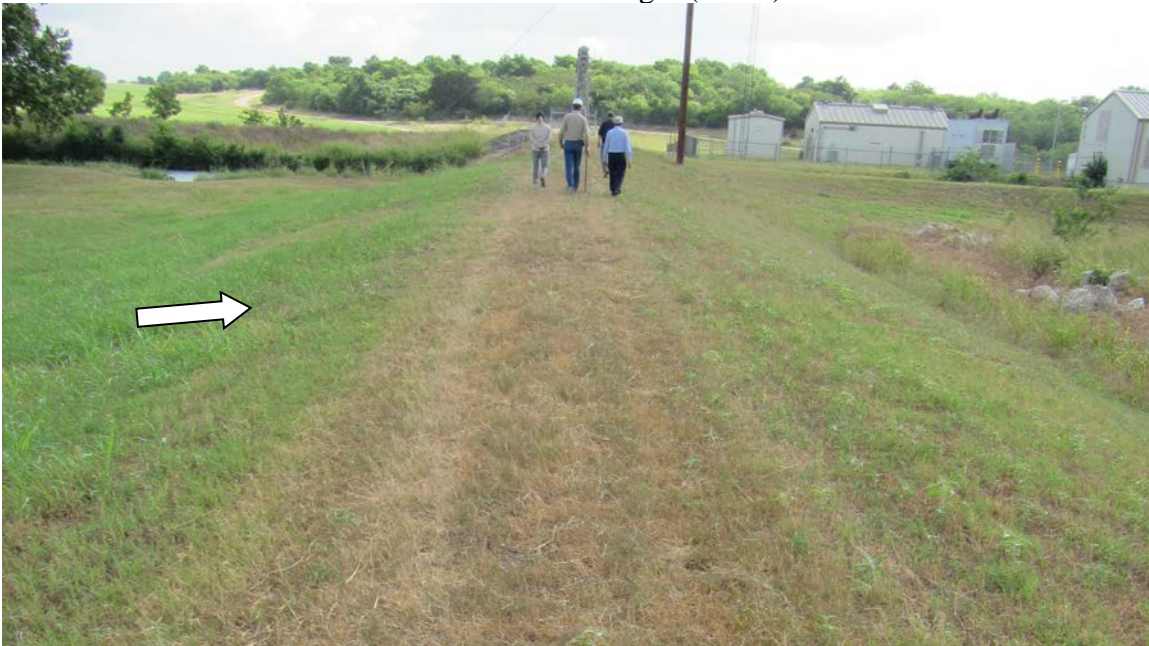
**Photo #22** – View from the control point of the emergency spillway looking northeast (diversion canal is in background). Note the good grass cover with no erosion or obstructions. Flow would be from left to right if the spillway engaged.

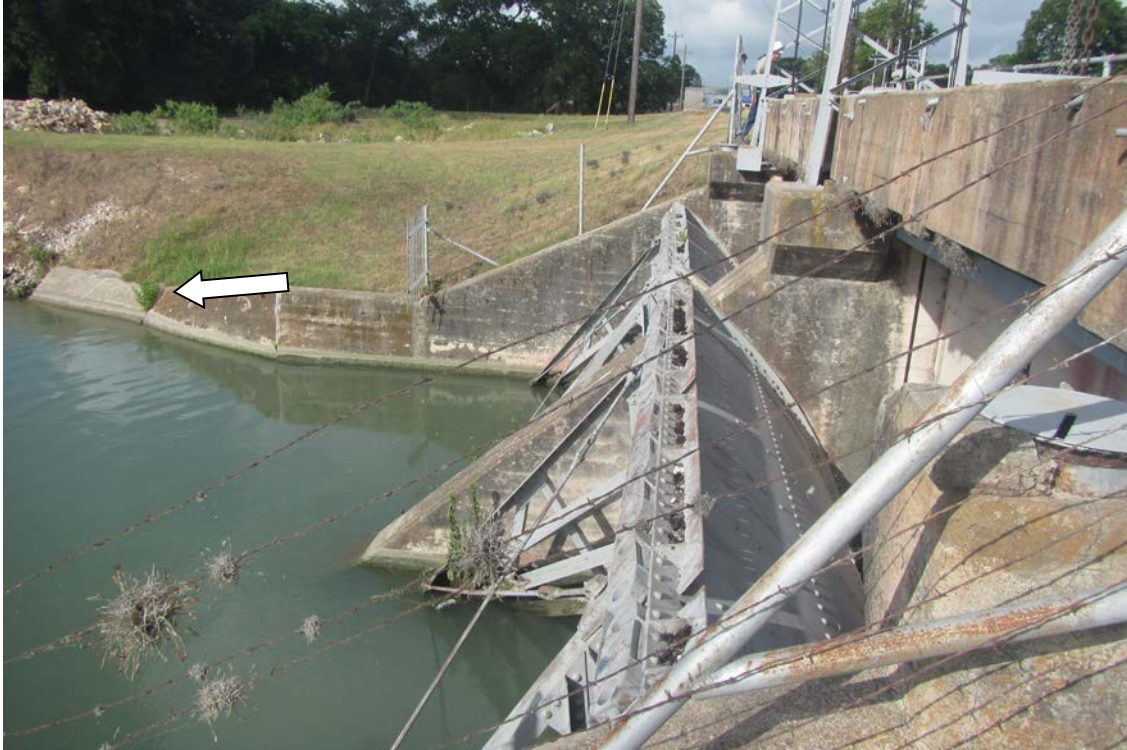
- Rust on the tainter gate trunions was noted in the previous inspection but was not observed during this inspection as the trunions were submerged.
- Some grass along the channel sidewalls was noted growing through parts of the concrete sidewalls.

**Photo #25** – View of the diversion canal and open radial tainter gates looking southwest. Note some grass growing through the sidewall.

- g) Remove all trees and unwanted vegetation from behind concrete walls, and slope protection around the canal headgate and powerhouse and turbine structures.

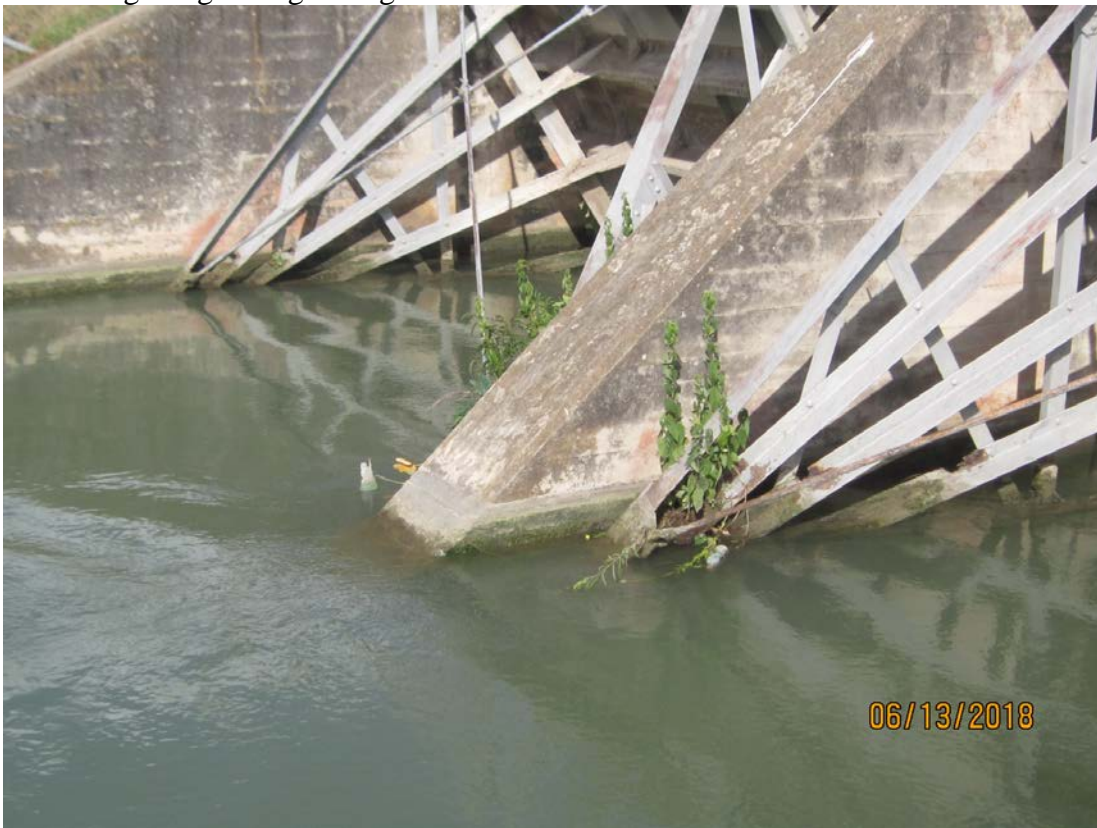
**Photo #26** – Close up view of the tainter gates looking west. The gates trunions were submerged and could not be observed. The gates remained in the open position.

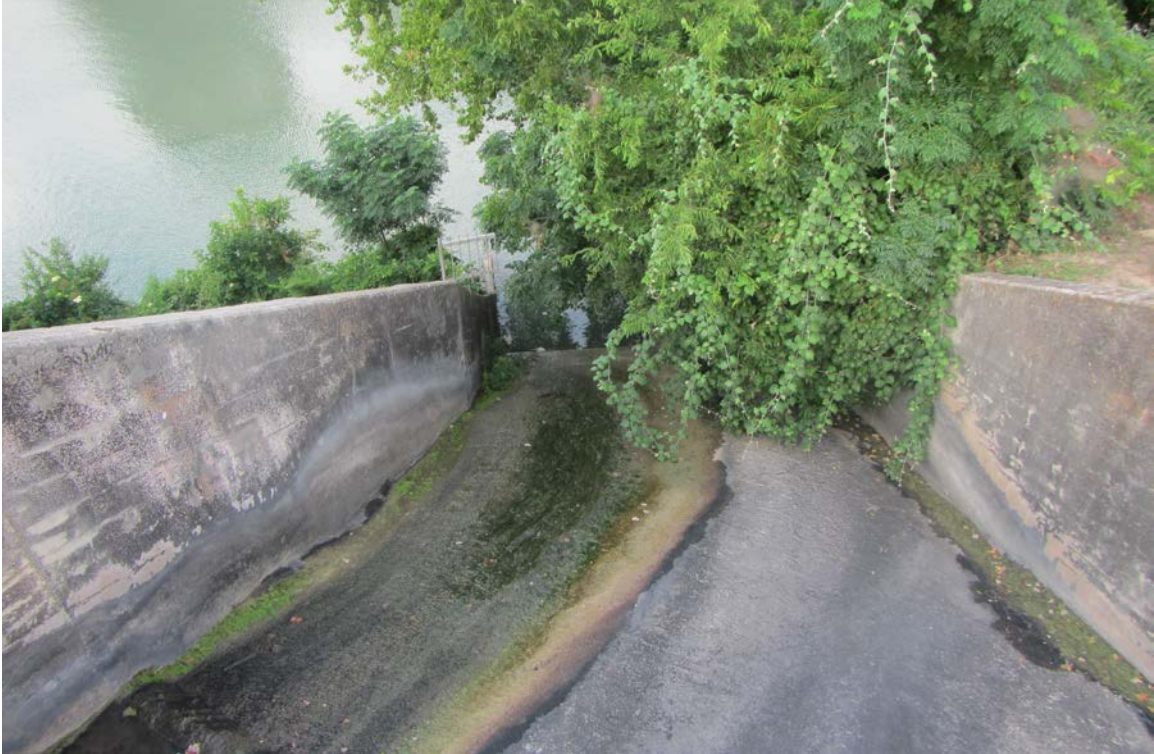
- The powerhouse and turbine generators were not assessed on operational conditions. However, GBRA did not report any operating deficiencies with the overall system. The concrete inlet and outlet structures were examined and found to be in good overall condition (See Photos 30-33).
- Small trees and shrubs were noted to be growing around the downstream end of the debris chute.

**Photo #32** – View from top of the concrete debris chute at the powerhouse looking southwest into main channel of the river. Note the overgrowth of trees and shrubs around the concrete sidewalls.
